# Research and practice of historic mortars and concrete

**Restoration Concrete for  
Historical Concrete  
Constructions**

**– Scientific Studies of old  
Concrete Samples from  
Finland**

Seminar & Workshop in Oslo  
27.- 28.11.2008

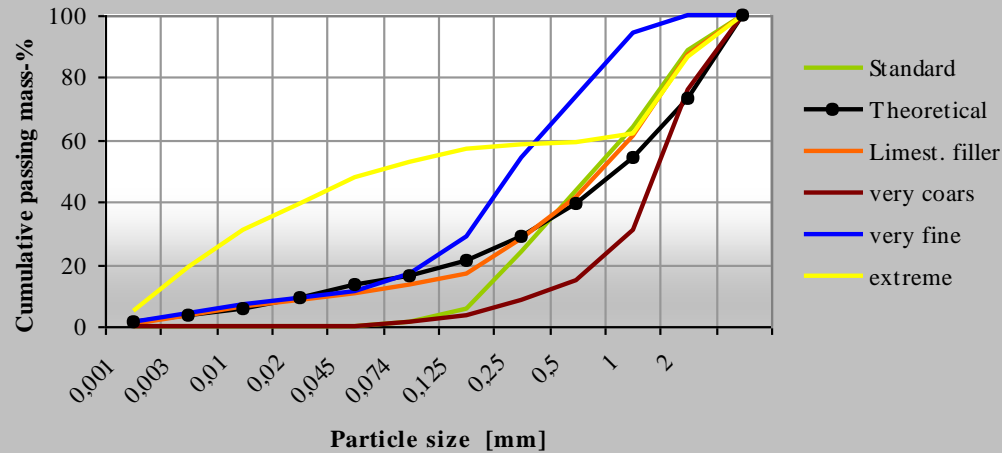
The aggregate grain size distribution works for lime mortars as for microproportioned concrete, but with a different starting point.

To improve the durability - frost resistance

Not to increase the compressive strength

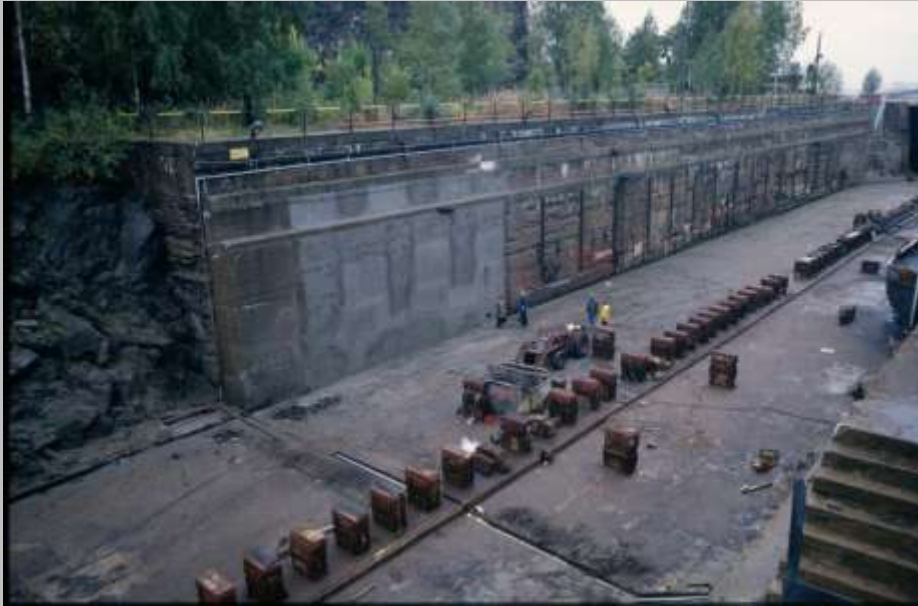
# Tests in situ on the walls of the dry dock

Concrete mixtures  
with 450 kg  
cement / m<sup>3</sup>

Special sand  
grading with  
quartzfiller

No chemical  
additives

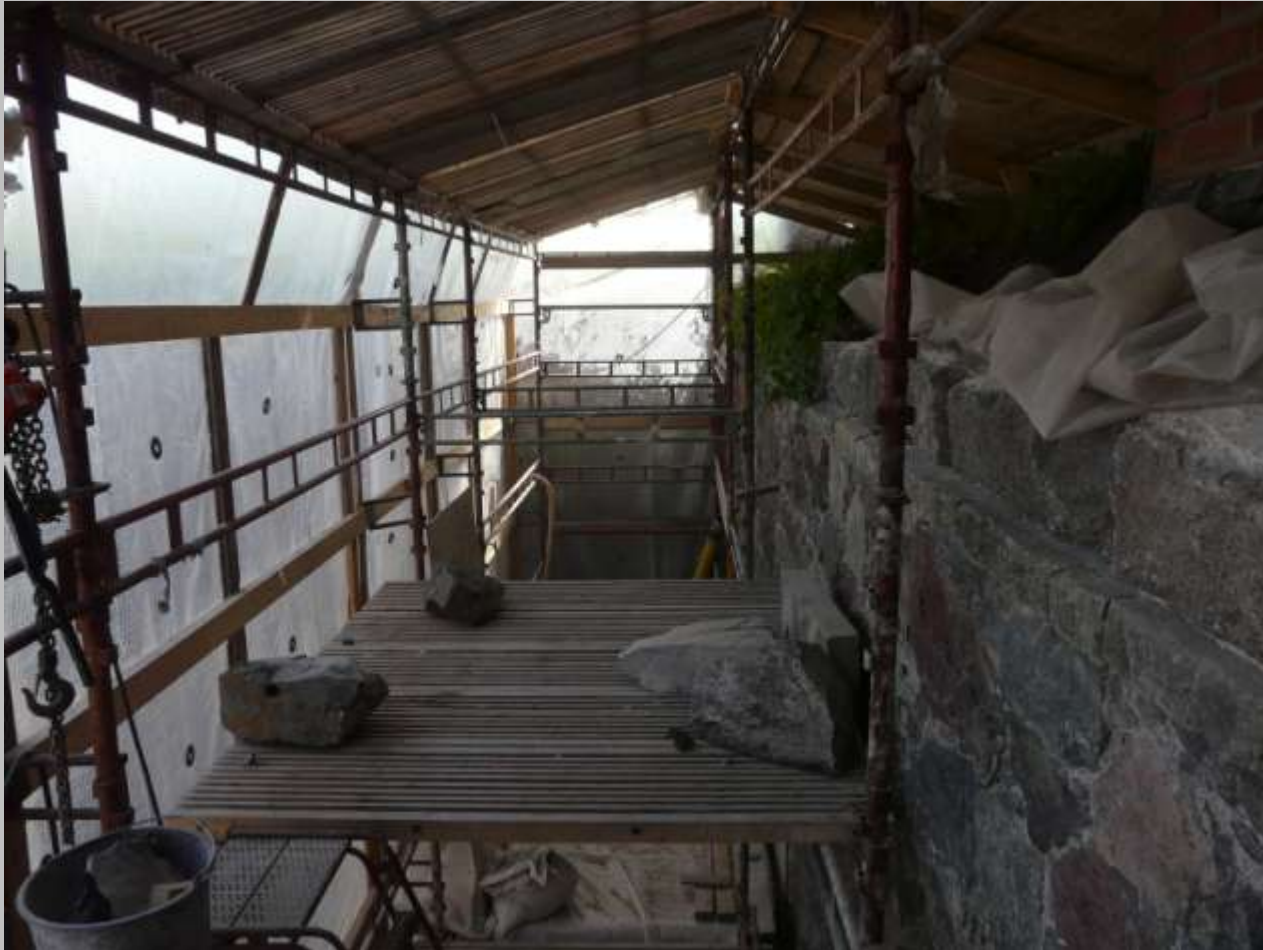
# Special “concrete” on top of the defence walls

## Concrete layer

NHL 5 with special graded sand 0 – 6 mm incl. quarts powder

1 : 2 by volume

without artificial additives

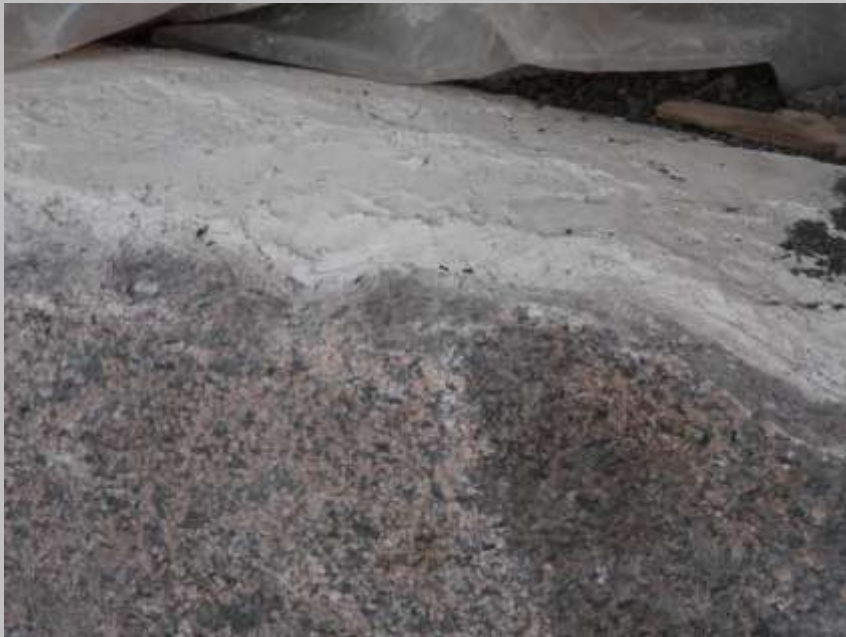
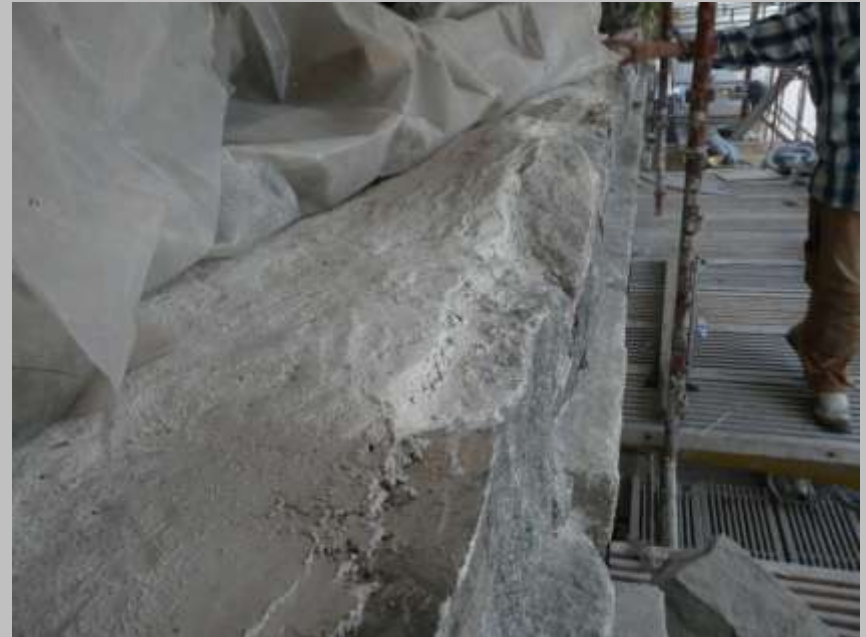
12 month curing in 65% RH

Density 1970 kg/m<sup>3</sup>

Compressive strength 8,8 MPa

Flexural strength 2,3 MPa
